Manhole Inspection Summary

Manhole # S17K1_011MH

Insp Date: **5/1/08 8:36 AM**

Location Address: **3011 lorena av**

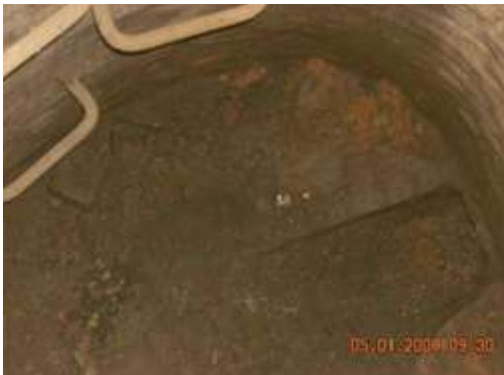
Defect 5

Condition: ☐ Sound ☐ Cracked ☐ Root Intrusion ☐ Deteriorated ☐ Leaks ☒ **Debris**

debris/mud on bench

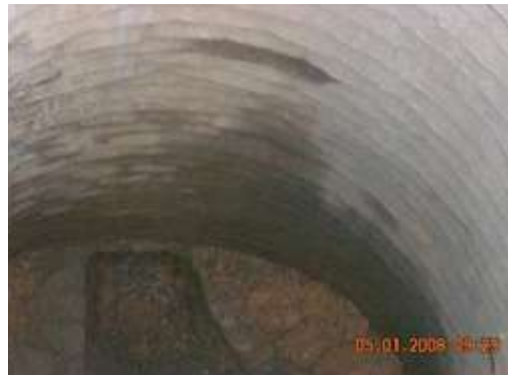
Defect 4

Infiltration: ☐ None ☐ Joint ☐ Cracks ☐ Mortar ☐ Roots ☒ **Wall**

infiltration @ barrel wall

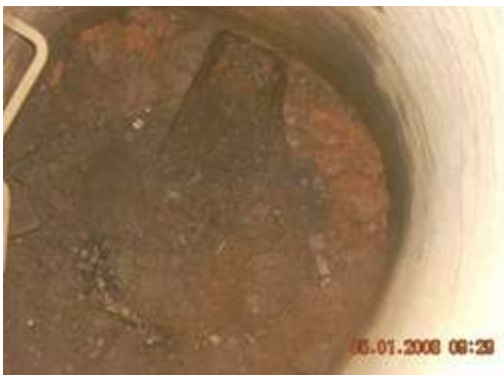
Defect 3

Condition: ☐ Sound ☐ Cracked ☐ Root Intrusion ☐ Deteriorated ☐ Leaks ☒ **Debris**

debris in channel

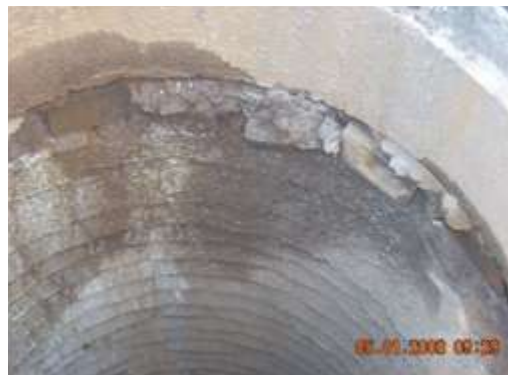
Defect 2

Infiltration: ☐ None ☒ **Joint** ☐ Cracks ☐ Mortar ☐ Roots ☐ Wall

infiltration @ chimney/frame joint

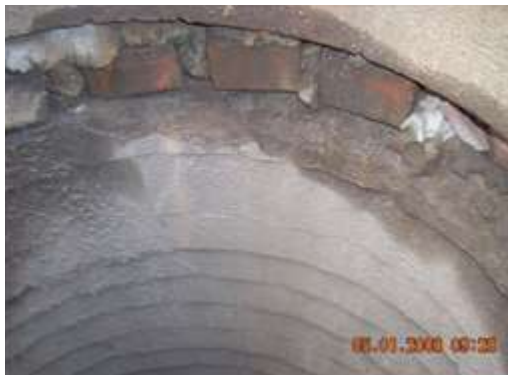
Defect 1

Condition: ☐ Sound ☐ Cracked ☐ Root Intrusion ☒ **Loose Brick** ☐ Deteriorated

loose chimney bricks

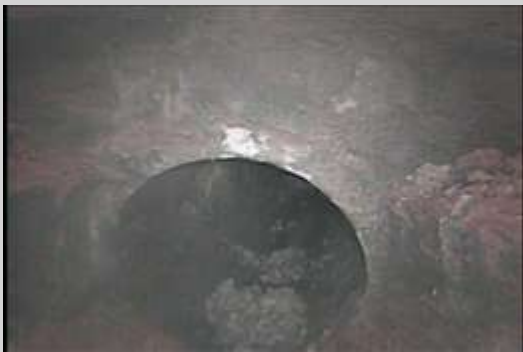
12 O'Clock Outflow

Deposits: ☐ None ☒ **Mud** ☐ Sludge ☐ Debris ☐ Grease

Silt Depth: **2** (in.) Deposits Extent: **Light**
